## SERVICE BULLETIN

**MACHINE OR VEHICLE AFFECTED:** TF Model MEWPs

**RISK IDENTIFIED:** Structural Cracks in Main Boom Rest

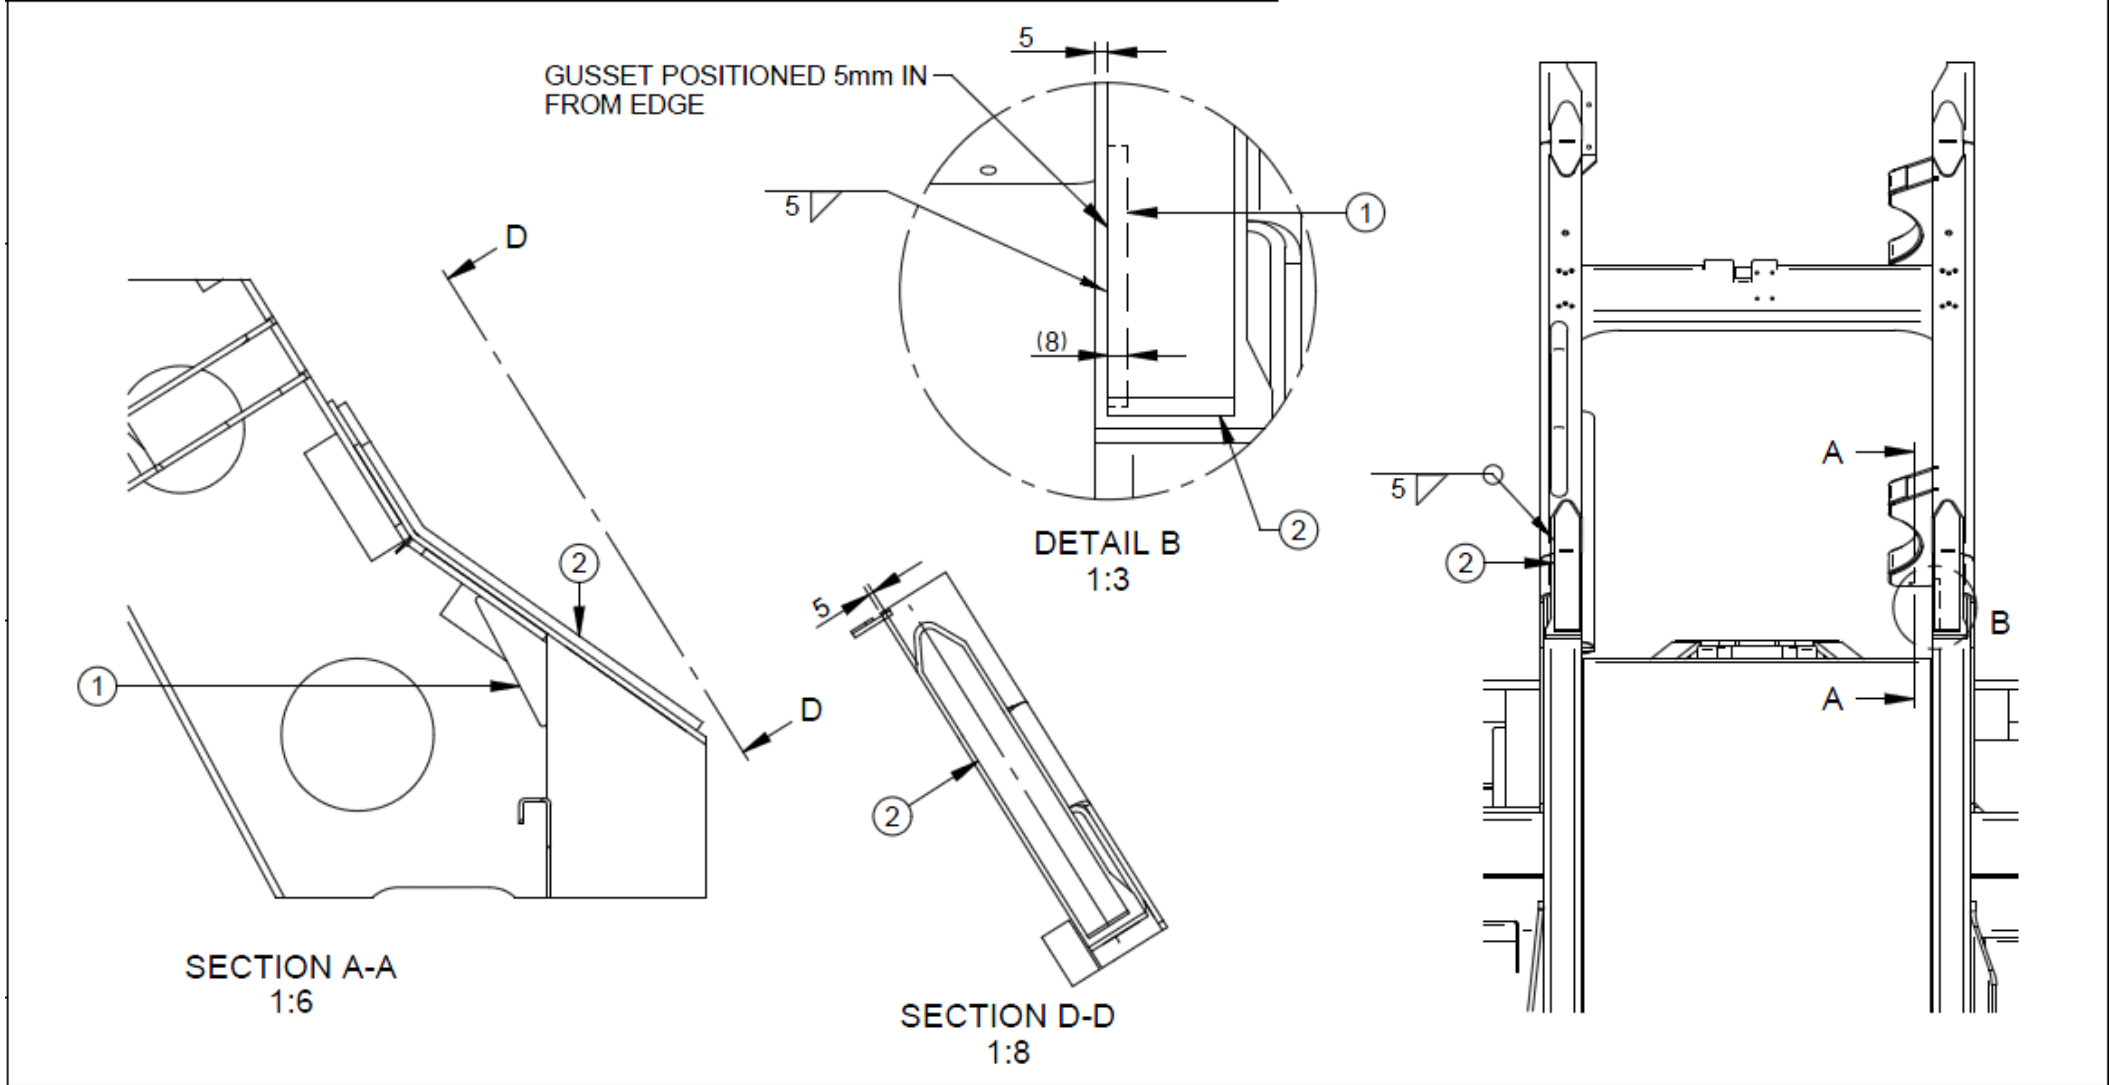
**DESCRIPTION:** Structural cracks can occur in the lower part of the main boom rest

1. Drill a 3mm hole in the end of each crack
2. Grind away all welds containing any cracks
3. Re-weld all welds that were ground away
4. Consult the assembly drawing found on page 2 and mark out all areas receiving new plates. Grind away surrounding paint to ensure a clean welding surface.

5. Make 2x Top doubler plates and 2x Bottom gussets. Drawings can be found on pages 3 & 4.
6. Weld in all 4 additional plates in accordance with the assembly drawing (page 2).
  - a. The electrical cable on the RHS must be well protected during welding to avoid damage.
7. Once cool, re-paint all exposed surfaces.
